# Punalu'u Stream Restoration Project

Punalu'u Community Association Update

# Punalu'u Stream Restoration

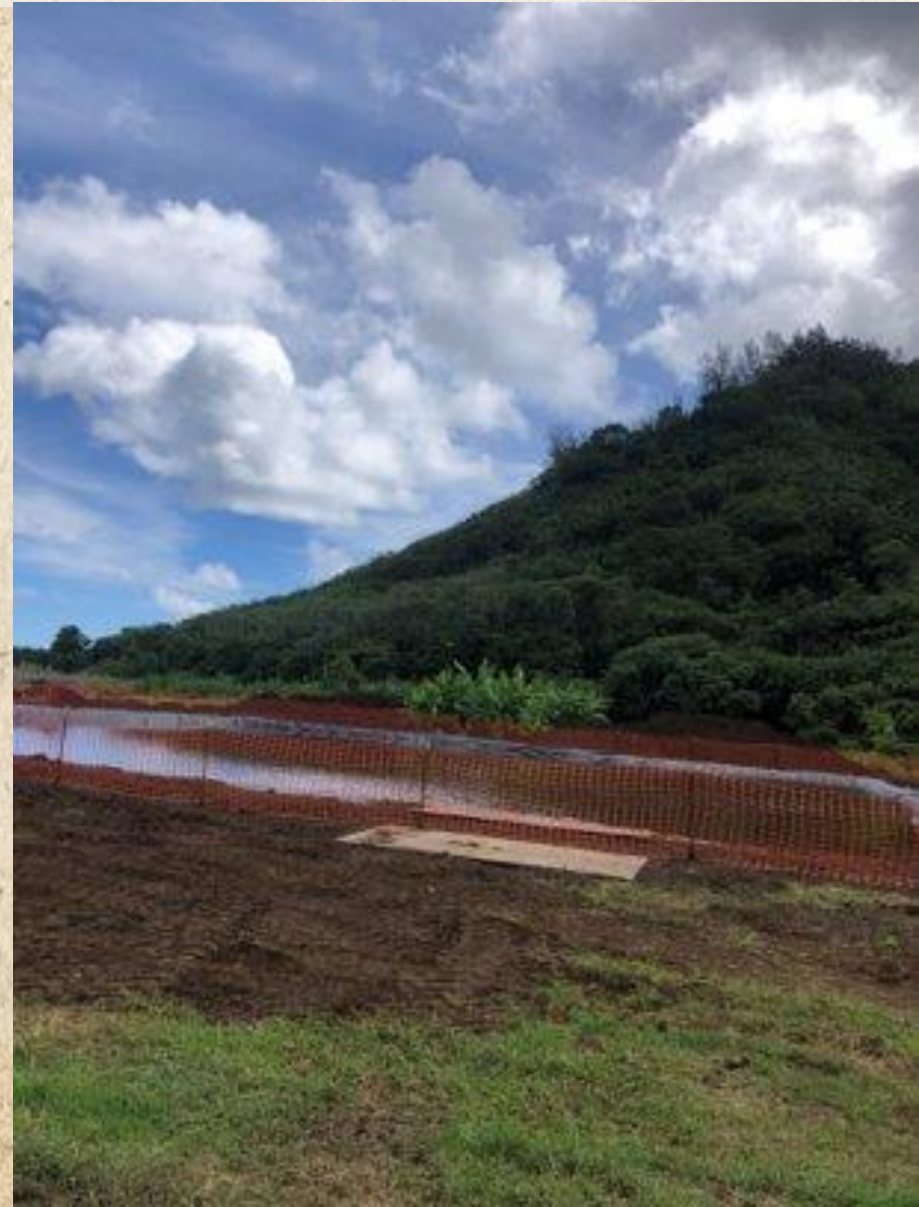
## **Best Management Practices Implemented**

- Our contractor, Goodfellow Bros, installed mandated erosion control measures that include nearly 6 miles of silt fencing around the perimeter of working areas. This fencing may be visible from Kamehameha Highway in places.
- We also shored up the existing front entrance with additional cobble and gravel material to help control mud and sediment from vehicles leaving the site. No excavated material will leave the site.

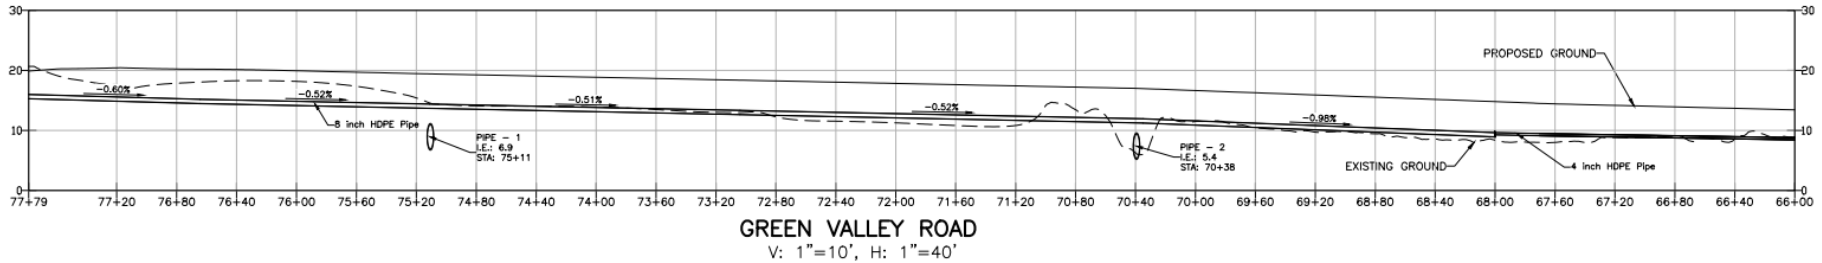
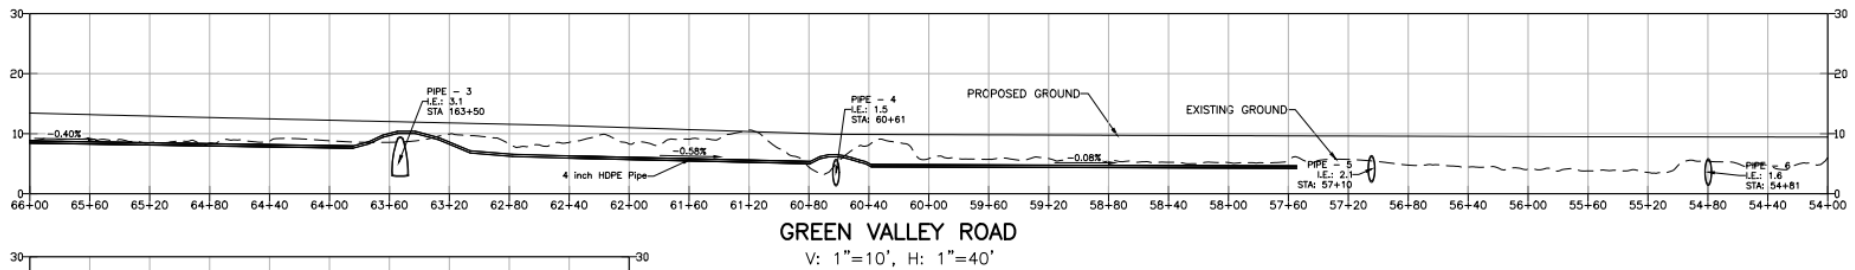
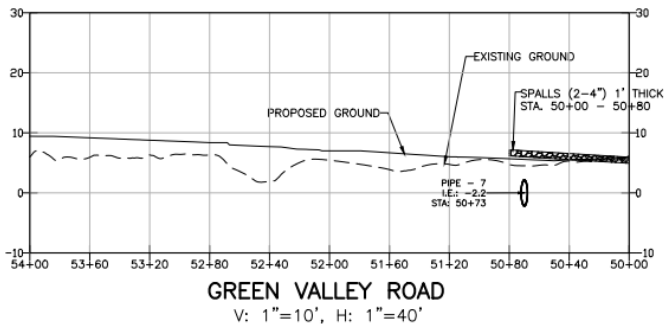
## Proposed New Green Valley Road (Main Access Road)

STA.	ELEVATION	NORTHING	EASTING	CROSS SECTION
50+00	0.00	148798.8	1680789.0	
51+00	7.39	148718.6	1680729.7	
52+00	8.31	148645.0	1680662.4	G-G
53+00	8.58	148578.4	1680587.8	
54+00	9.43	148518.1	1680508.0	H-H
55+00	9.47	148458.3	1680427.9	
56+00	9.52	148399.5	1680347.0	I-I
57+00	9.60	148342.0	1680265.2	
58+00	9.67	148284.6	1680183.3	J-J
59+00	9.76	148227.2	1680101.4

STA.	ELEVATION	NORTHING	EASTING	CROSS SECTION
60+00	9.85	148169.8	1680019.6	K-K
61+00	10.20	148115.5	1679935.6	
62+00	11.00	148063.2	1679850.4	L-L
63+00	11.68	148018.7	1679761.1	
64+00	12.24	147978.6	1679669.6	M-M
65+00	12.81	147933.4	1679580.3	
66+00	13.43	147888.3	1679491.1	N-N
67+00	14.05	147843.1	1679401.9	
68+00	14.80	147792.0	1679316.6	O-O
69+00	15.72	147726.9	1679240.7

STA.	ELEVATION	NORTHING	EASTING	CROSS SECTION
70+00	16.65	147681.8	1679164.9	P-P
71+00	17.32	147602.1	1679084.8	
72+00	17.83	147545.3	1679002.5	Q-Q
73+00	18.35	147488.5	1678920.2	
74+00	18.85	147425.3	1678842.7	R-R
75+00	19.36	147361.9	1678765.4	
76+00	19.94	147307.1	1678681.8	S-S
77+00	20.33	147247.7	1678602.2	
77+80.8	19.85	147170.5	1678591.9
